Ex-situ X-ray computed tomography, tension clamp and in-situ transilluminated white light imaging data of non-crimp fabric based fibre composite under fatigue loading

Published in:
Data in Brief

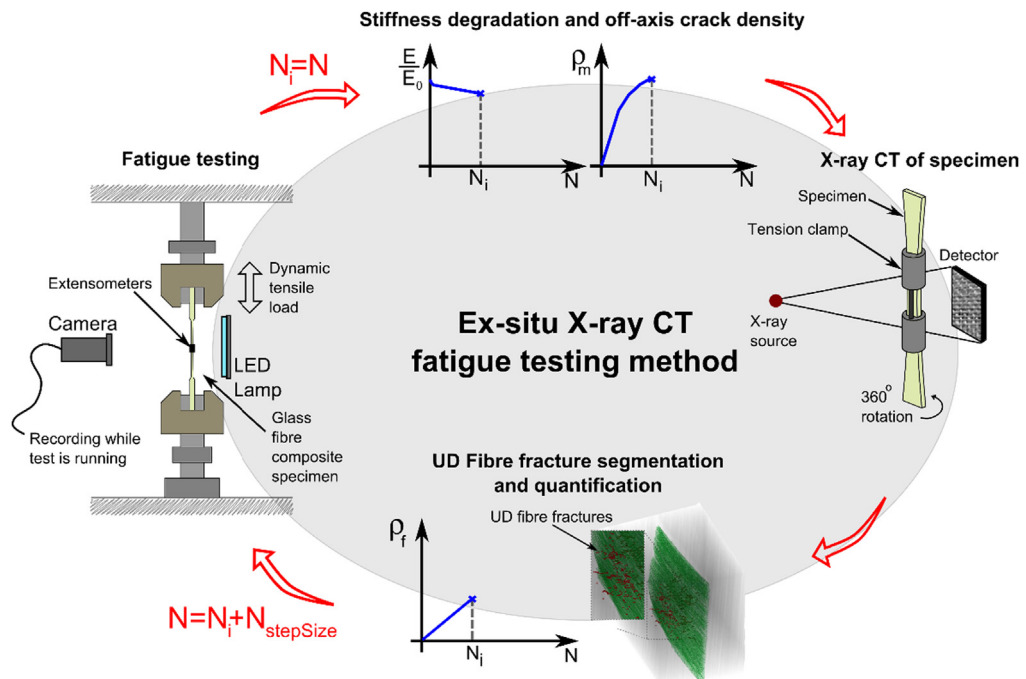
Fig. 1. Overall idea behind ex-situ X-ray CT fatigue testing approach supplemented by TWLI and tension clamp.

The methods used to obtain the data provided with this paper are based on the idea shown in Fig. 1, which shows the general principle of the ex-situ X-ray CT fatigue testing method. To overcome some of the challenges of X-ray CT, TWLI and tension clamp experiments were also carried out as supplements. The TWLI was carried out during the fatigue test as illustrated by the camera and LED lamp in the left-hand image of Fig. 1. The tension clamp data provided with this paper is not included in the ex-situ testing loop this time, however it could be included in future work as illustrated in the left-hand image of Fig. 1 to improve the crack visibility. The below sections outline the specifics of the individual testing methods.

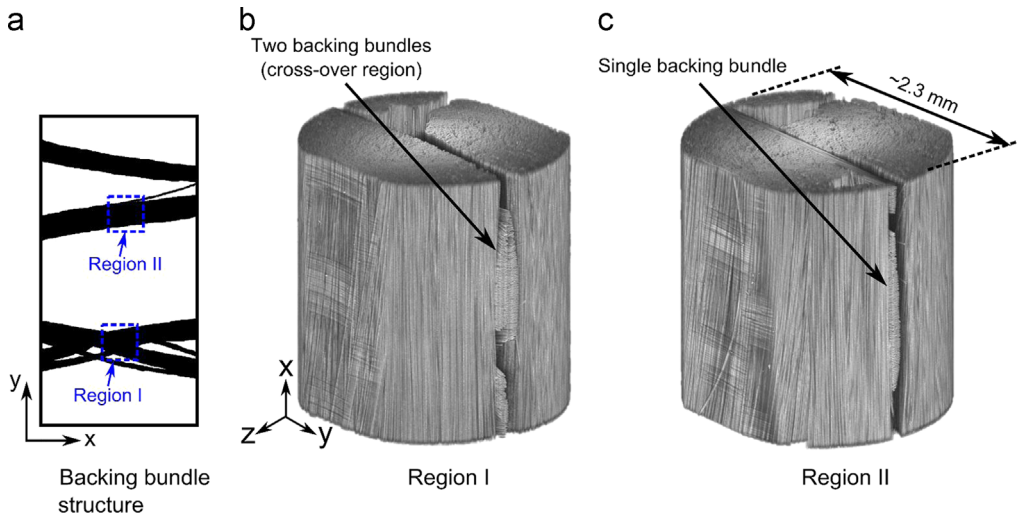
Fig. 2. The approximate locations of the two regions considered by X-ray CT in specimen EPS06-1 are shown on top of the bundle structure in (a) and the 3D volumes obtained by X-ray CT are shown in (b) and (c) for region I and II, respectively.

High resolution X-ray CT with a pixel size of $2.25 \mu\text{m}$ was used for both the ex-situ study and the tension clamp experiments. For the ex-situ experiments, the source-to-sample and detector-to-sample distances were 20 mm and 40 mm respectively, and the exposure time was 2.5 s. Two regions were considered ex-situ in the specimen (EPS06-1 in Table 1) as illustrated by region I and II in Fig. 2. Region I was scanned before any testing had been done to the specimen at each of the interruption points (100,000, 150,000, 200,000, and 500,000 cycles). Region II was only scanned at the last three interruption points (150,000, 200,000, and 500,000 cycles). Fig. 3 shows an example of a 2D slice view of region II for the three interruption points. This results in 8 datasets for the ex-situ study. For clarity the data for the tension clamp have “ex-situ_” in front of the file name. The detailed scan settings are also provided as “ex-situ_info1.png” and “ex-situ_info1.png”.
